Aztech Environmental

RE: Sub-Slab Depressurization System (SSDS) – 2016 Annual Inspection

The three (3) SSDS installed at 510 Furnace Dock Road (the site) located in Cortlandt Manor, New York have been operational since their installation in December of 2011. Each of the three (3) individual systems is comprised of two (2) sub-slab vapor extraction points. The northern system is equipped with Radonaway HS-5000 fan unit, and the central and southern systems are equipped with Radonaway HS-2000 fan units. Each system is equipped with a pressure indicating alarm which illuminates a light in the event that the vacuum inside of the system falls below 0.25 inches of water column. All plumbing was completed using three-inch Schedule 40 PVC pipe and solvent-welded fittings. The three (3) fans were mounted securely to the roof and all piping was installed on a pitch to allow any condensation to flow back into the ground beneath the building's slab.

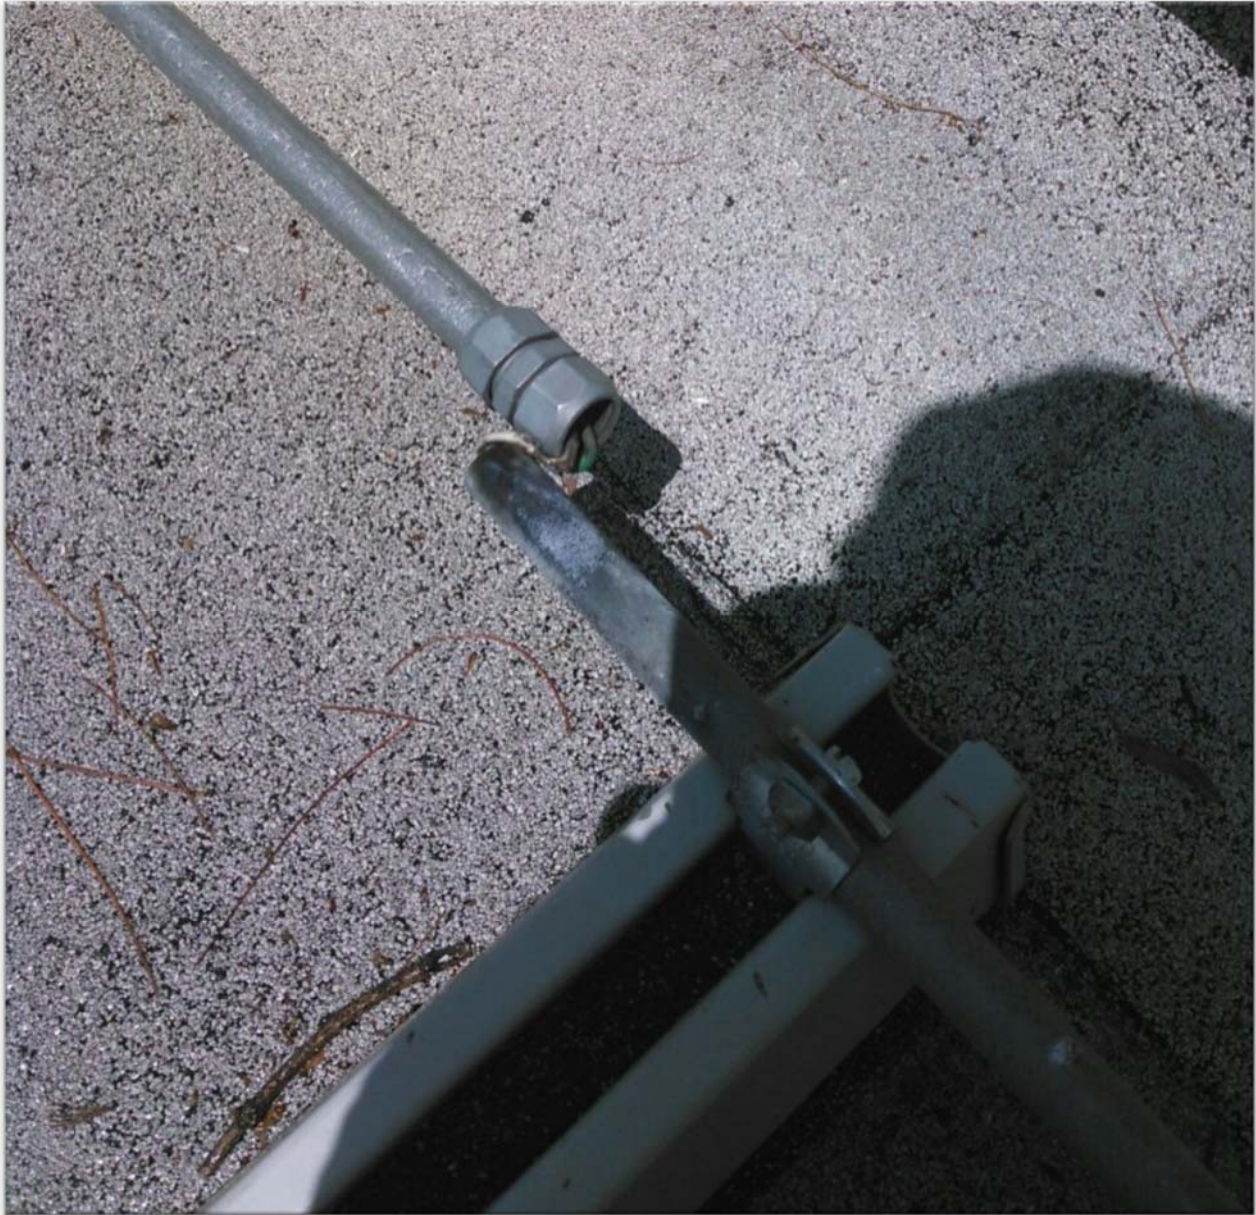
It was identified that a portion of the rigid conduit which carries power to the exterior electrical outlets was disjointed at a fitting. The cause of the issue is unknown but upon identification, the electrician who conducted the installation was contacted and a repair was completed.

Seen here is a separation in the rigid conduit that conveys power to the Northern Fan. This was likely caused due to snow accumulation/melting cycles and frost heaving. The separation was repaired.

No Smoke test conducted due to the
Sensitivity of work performed inside of the
building. All exposed joints were visually
inspected. All supports inspected.
Fans appear to be operational.
* Disjuncted conduit identified on roof.

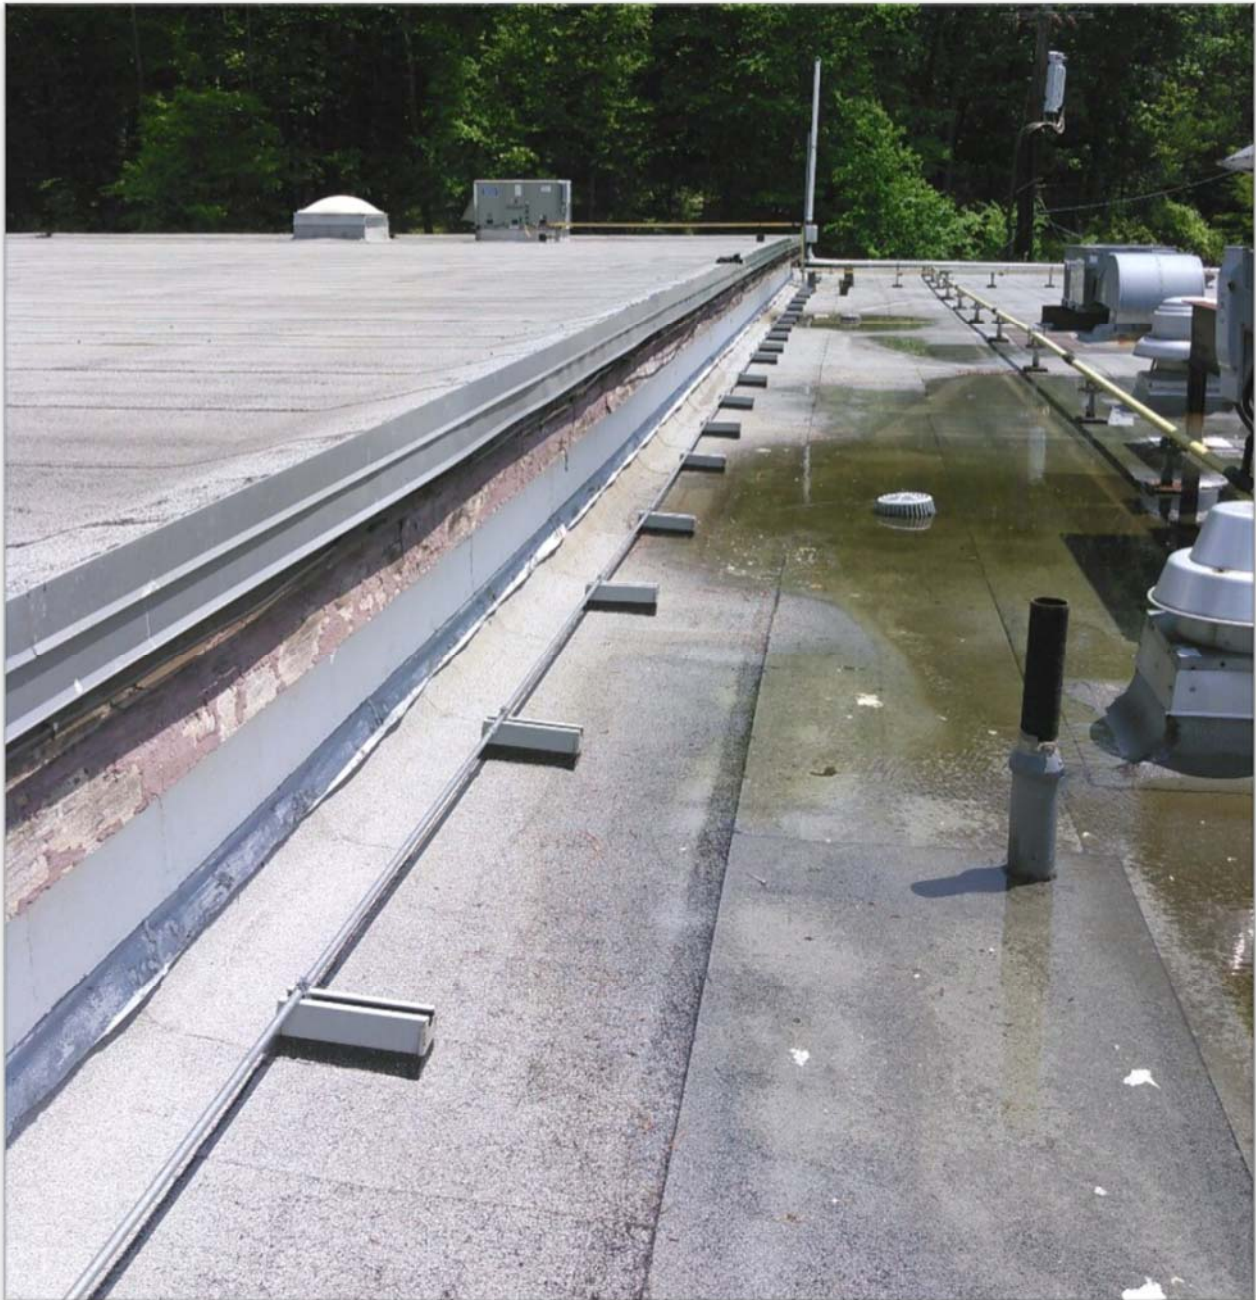
Seen here is the rigid conduit that conveys power to the Northern Fan after repairs were completed.
